44-9-8-59

**REPORT OF AIRCRAFT ACCIDENT**

(1) Place **Kellogg Field, Battle Creek, Mich.,** (2) Date **8 Sept. 1943** (3) Time **1515**  
 AIRCRAFT: (4) Type and model **B-24-D** (5) A. F. No. **42-72891** (6) Station **Herington, Kansas**  
 Organization: (7) **2nd A.F.** (8) **6th H.Proc.** (9) **7343**  
 (Command and Air Force) (Group) (Squadron)

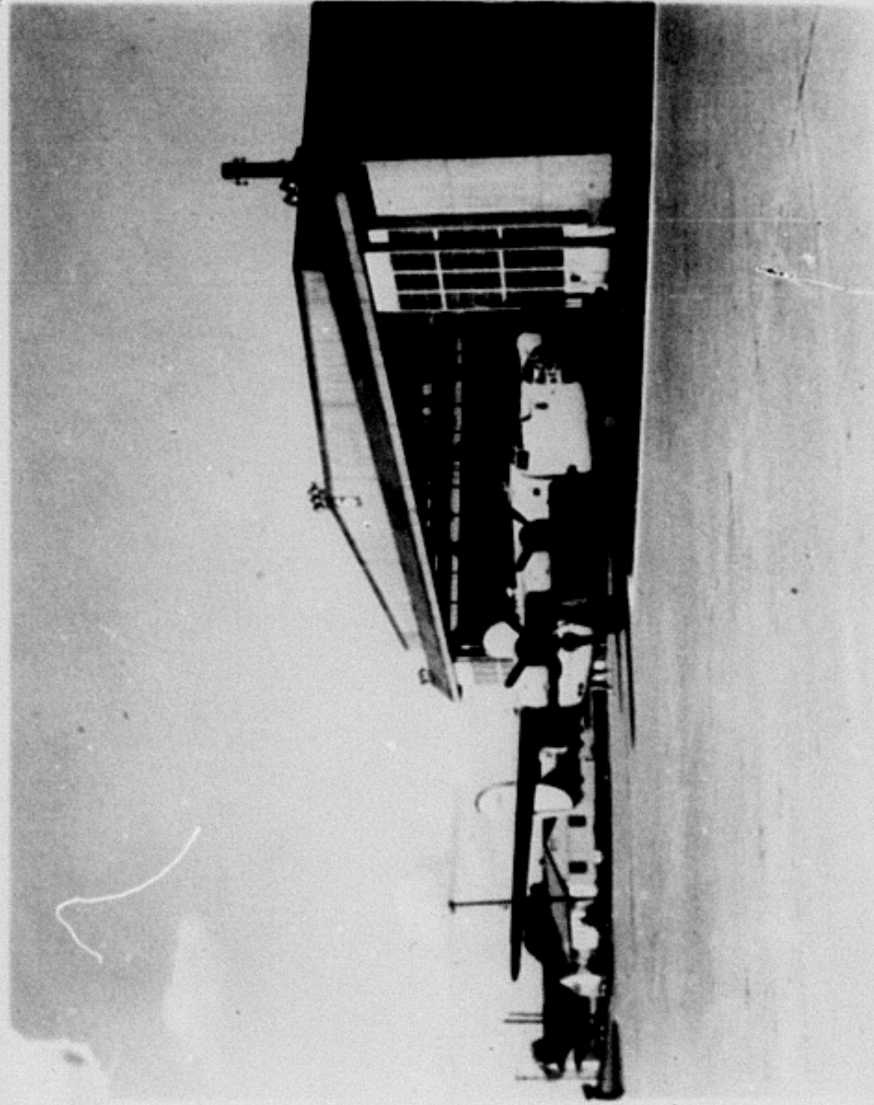
(57) Cause of accident **Left brake did not hold and plane swung to right hitting hangar wall prop on No. 1, hit hangar doors ruining prop.**

PRON & HANGAR DOOR DAMAGE

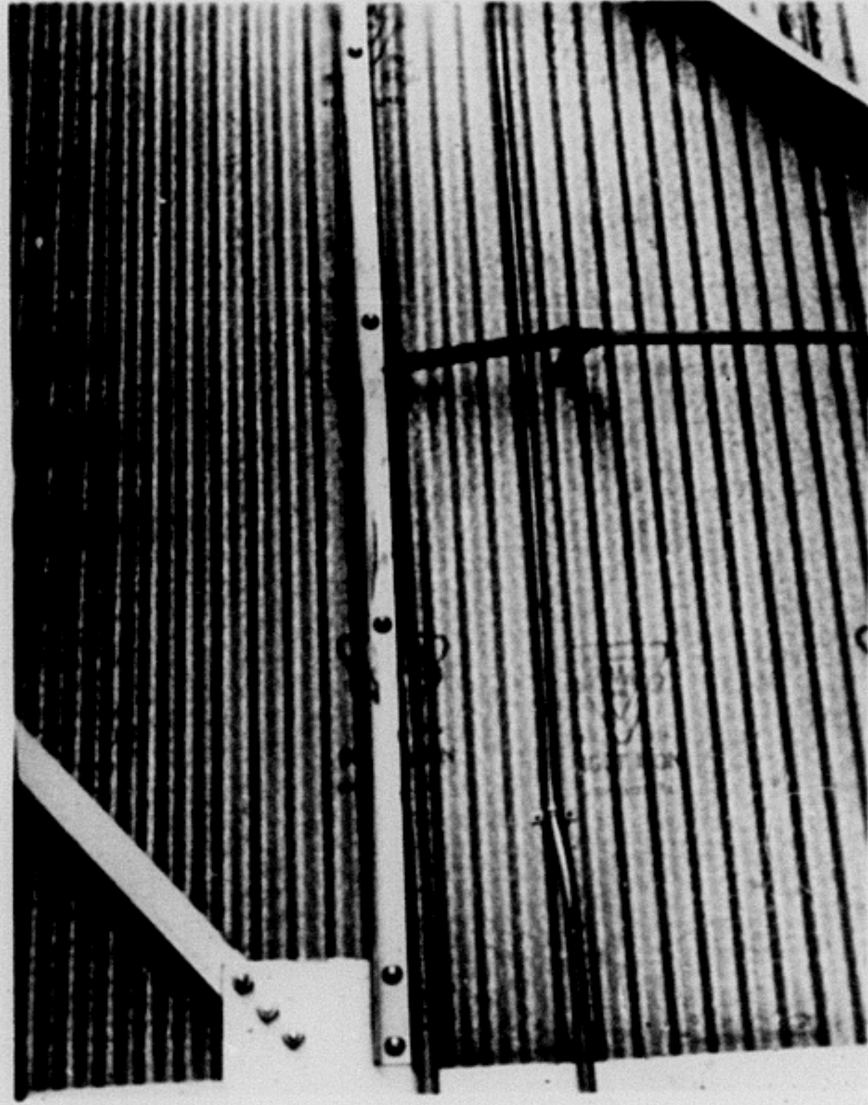
BROKEN WATER PIPE IN HANGAR

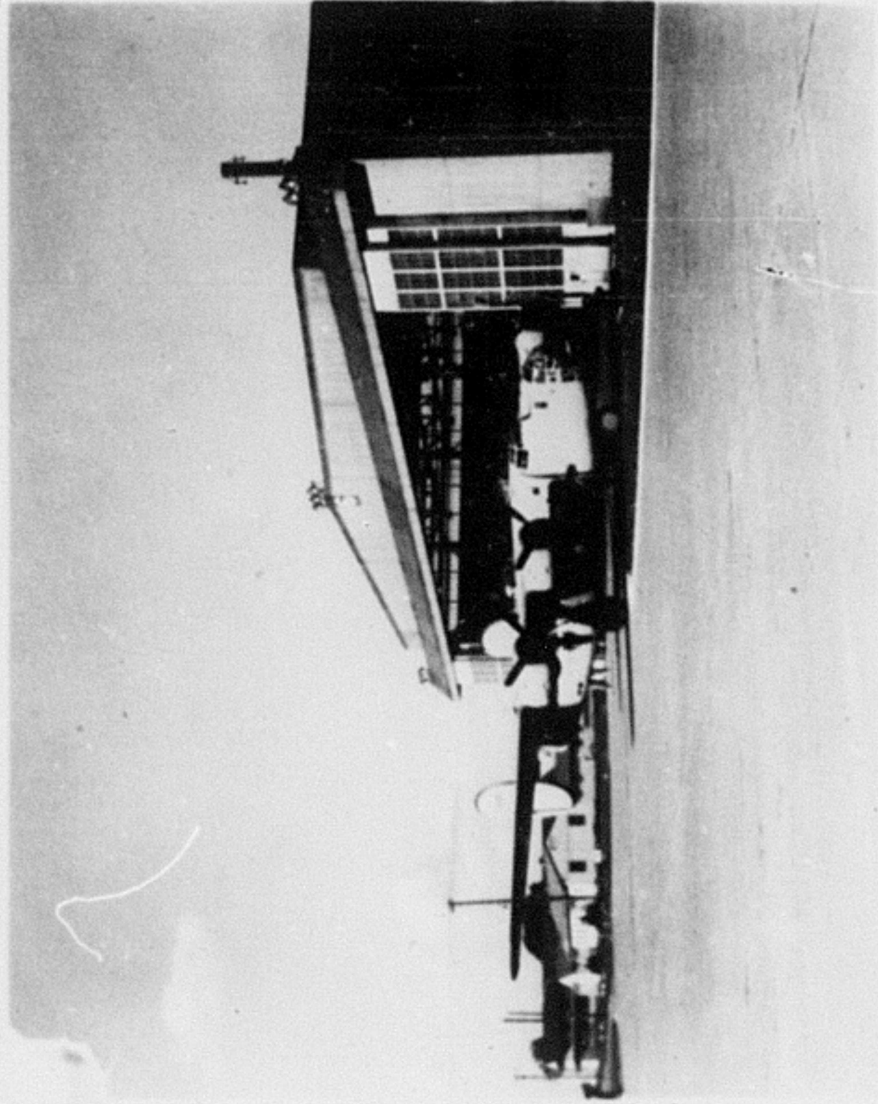
PIZZON & HANGAR DOOR DAMAGE

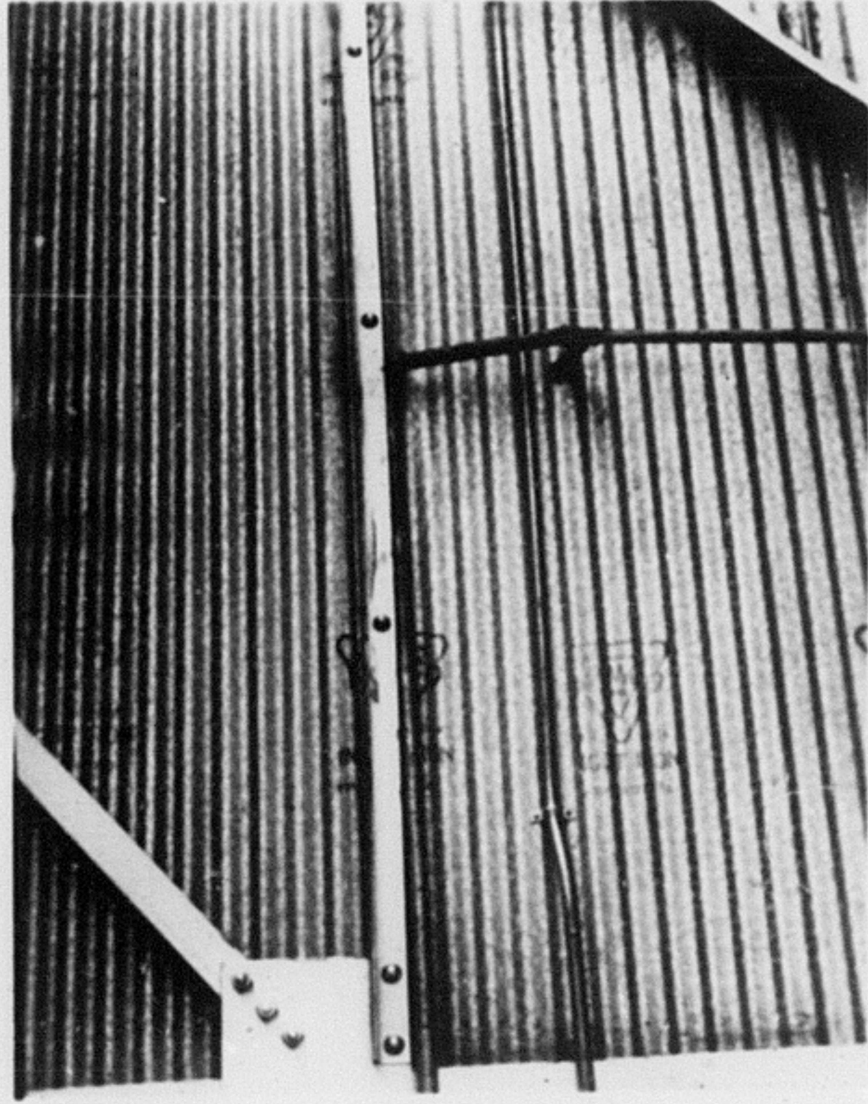
BROKEN WATER PIPE IN HANGAR

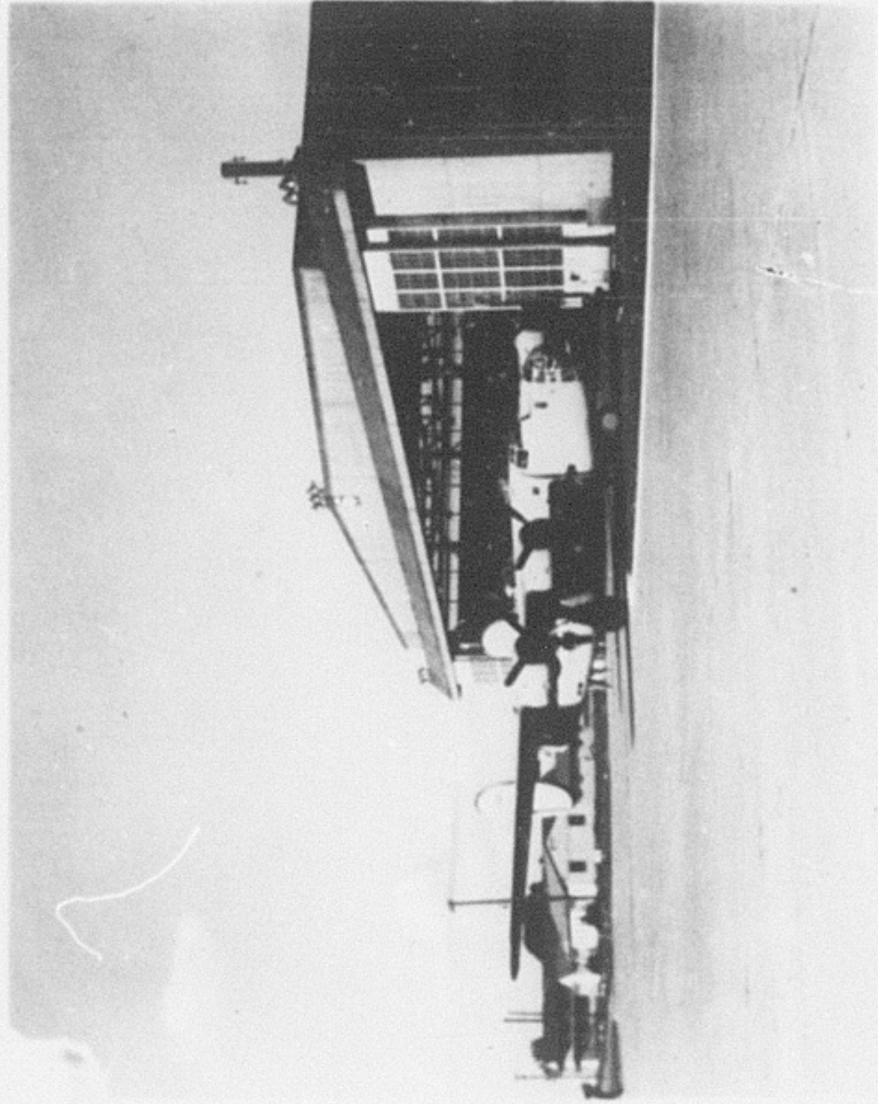
PIRON & HANGAR DOOR DAMAGE

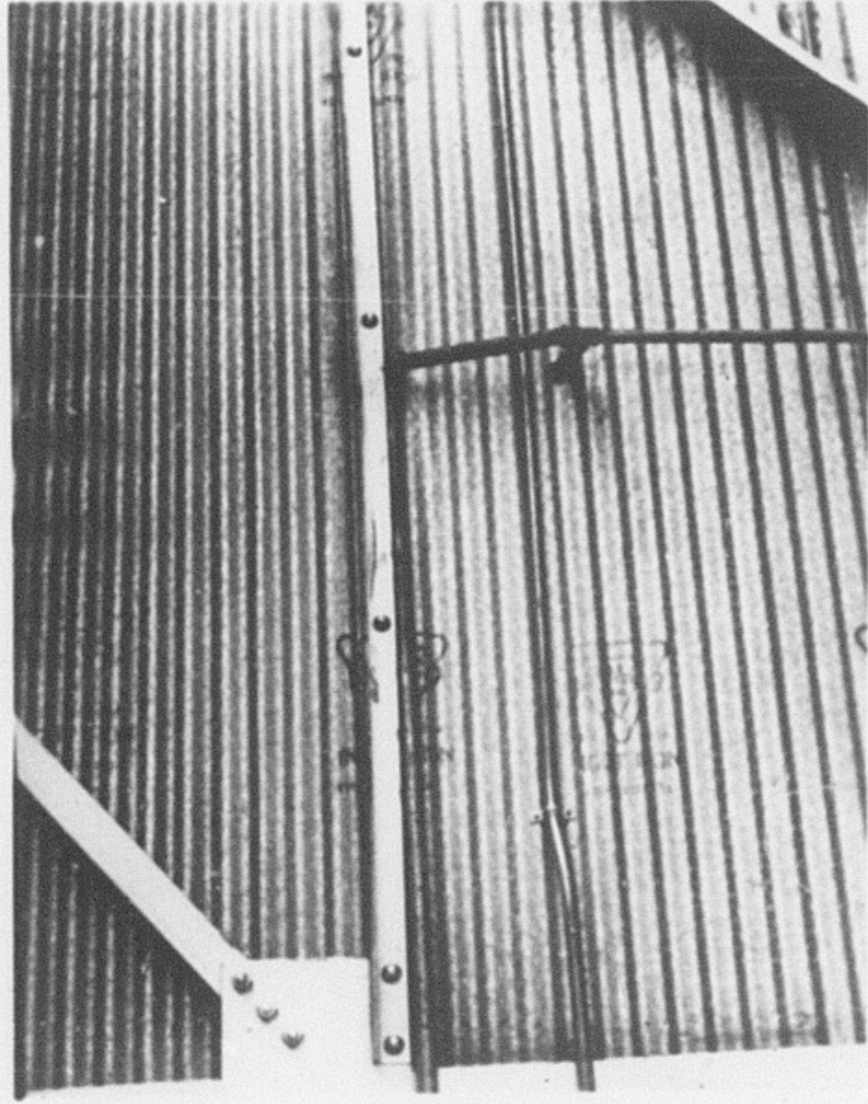
BROKEN WATER PIPE IN HANGAR

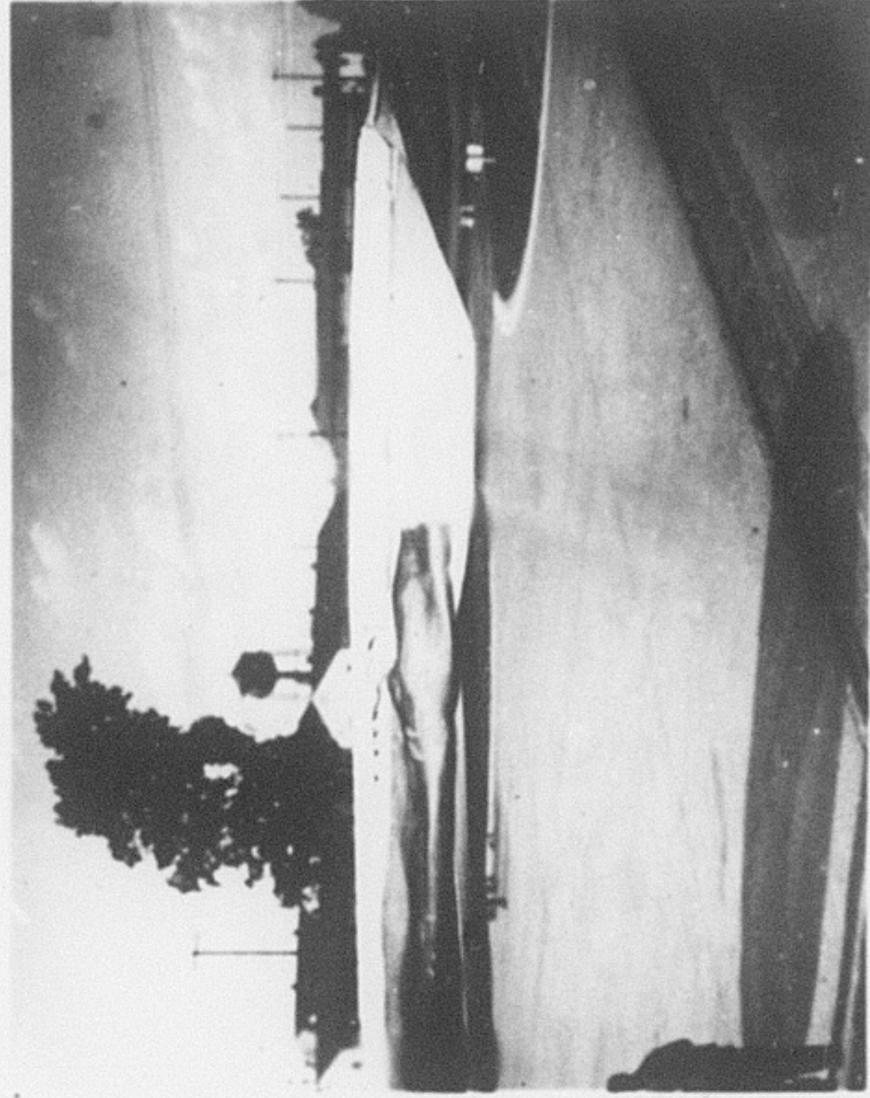
WING DAMAGE

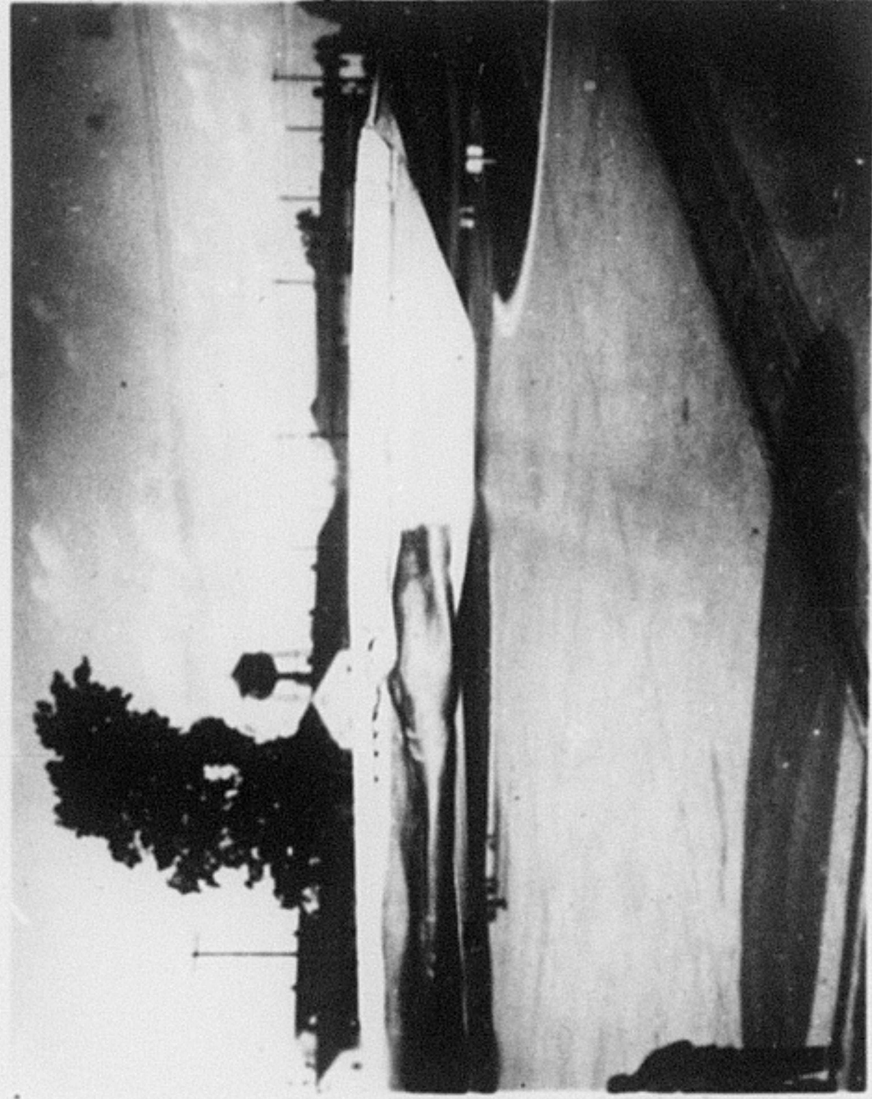
WING DAMAGE

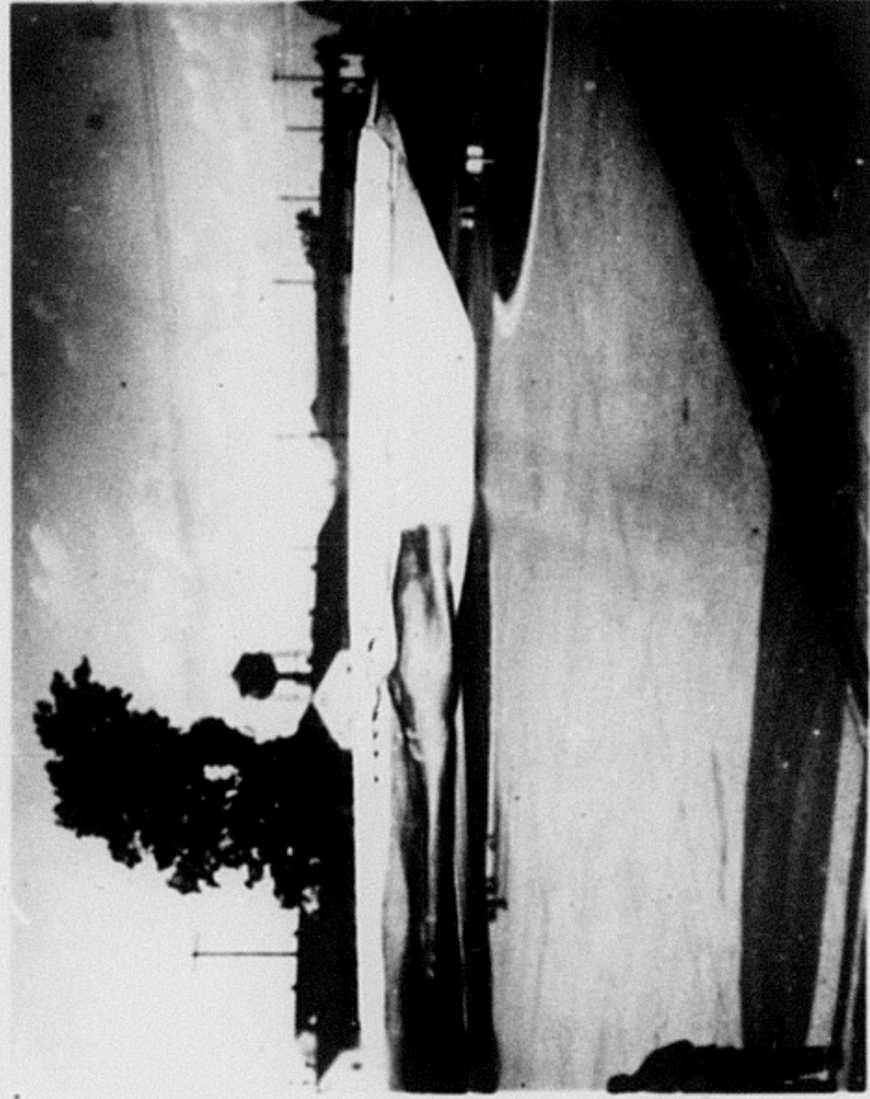
WING DAMAGE

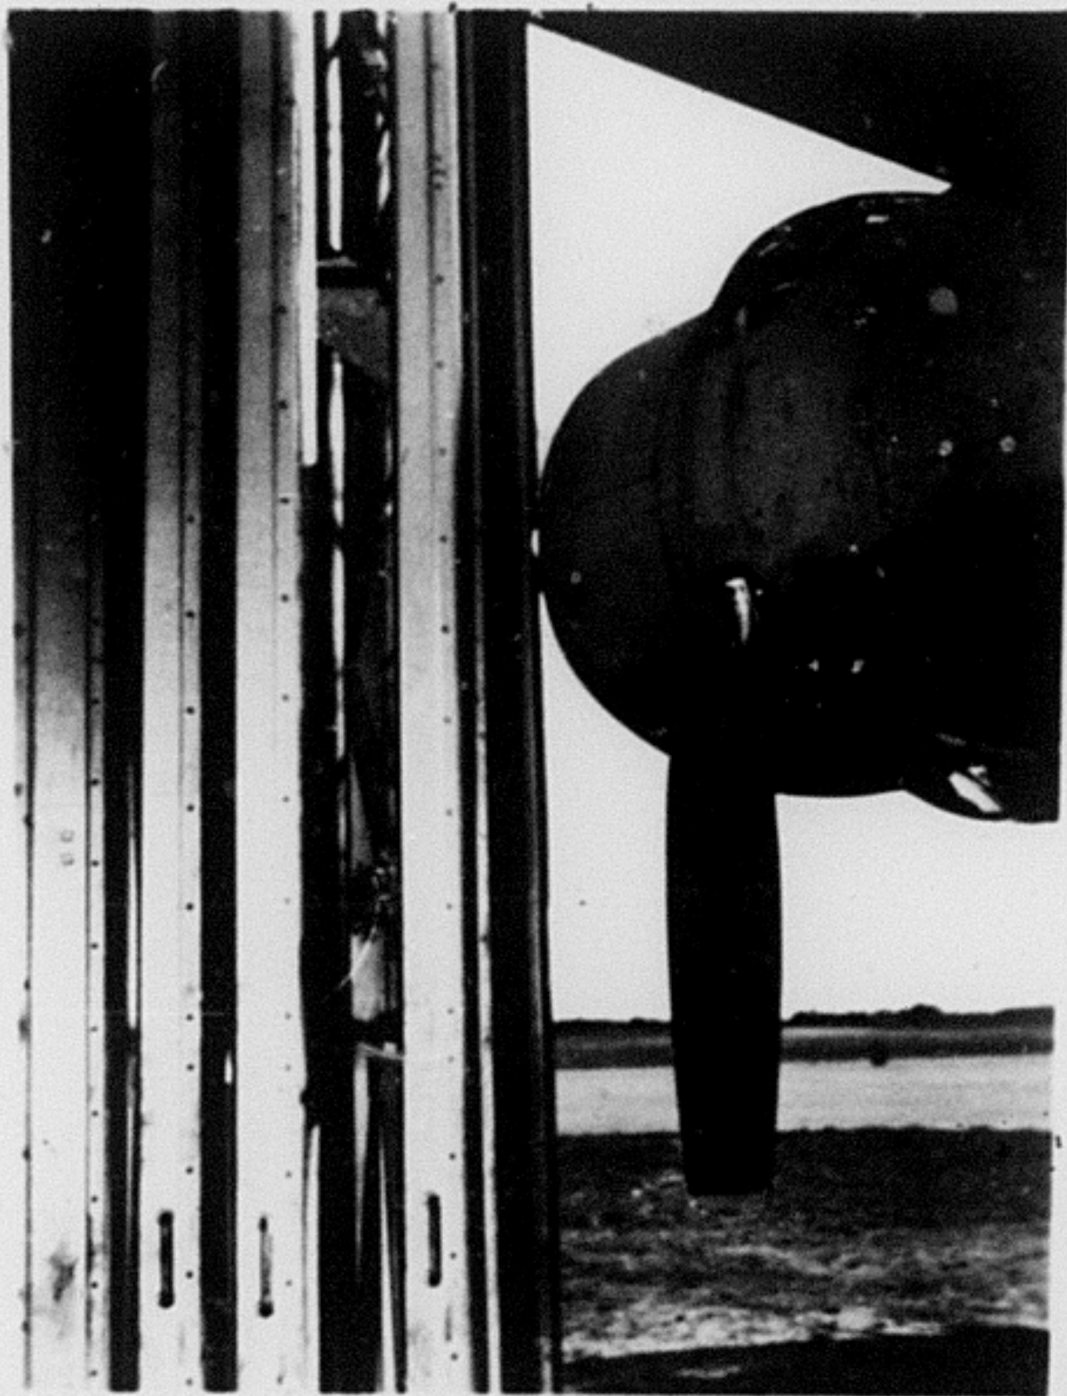
PROP & HANGAR DOOR DAMAGE 9-8-43

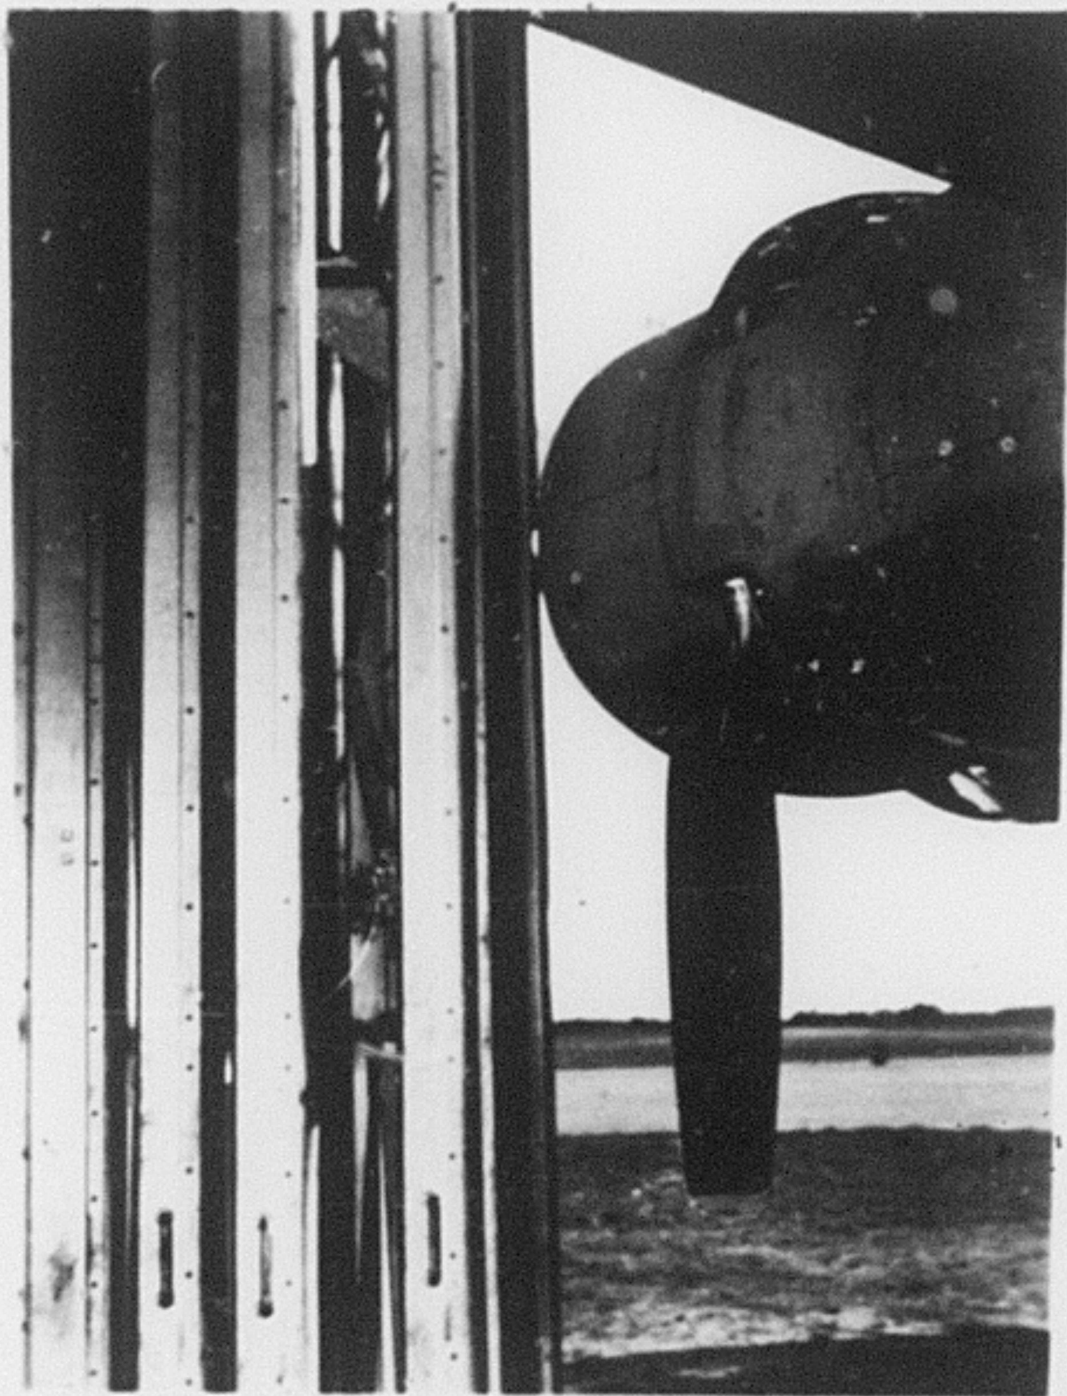
PROP & HANGAR DOOR DAMAGE 9-8-43

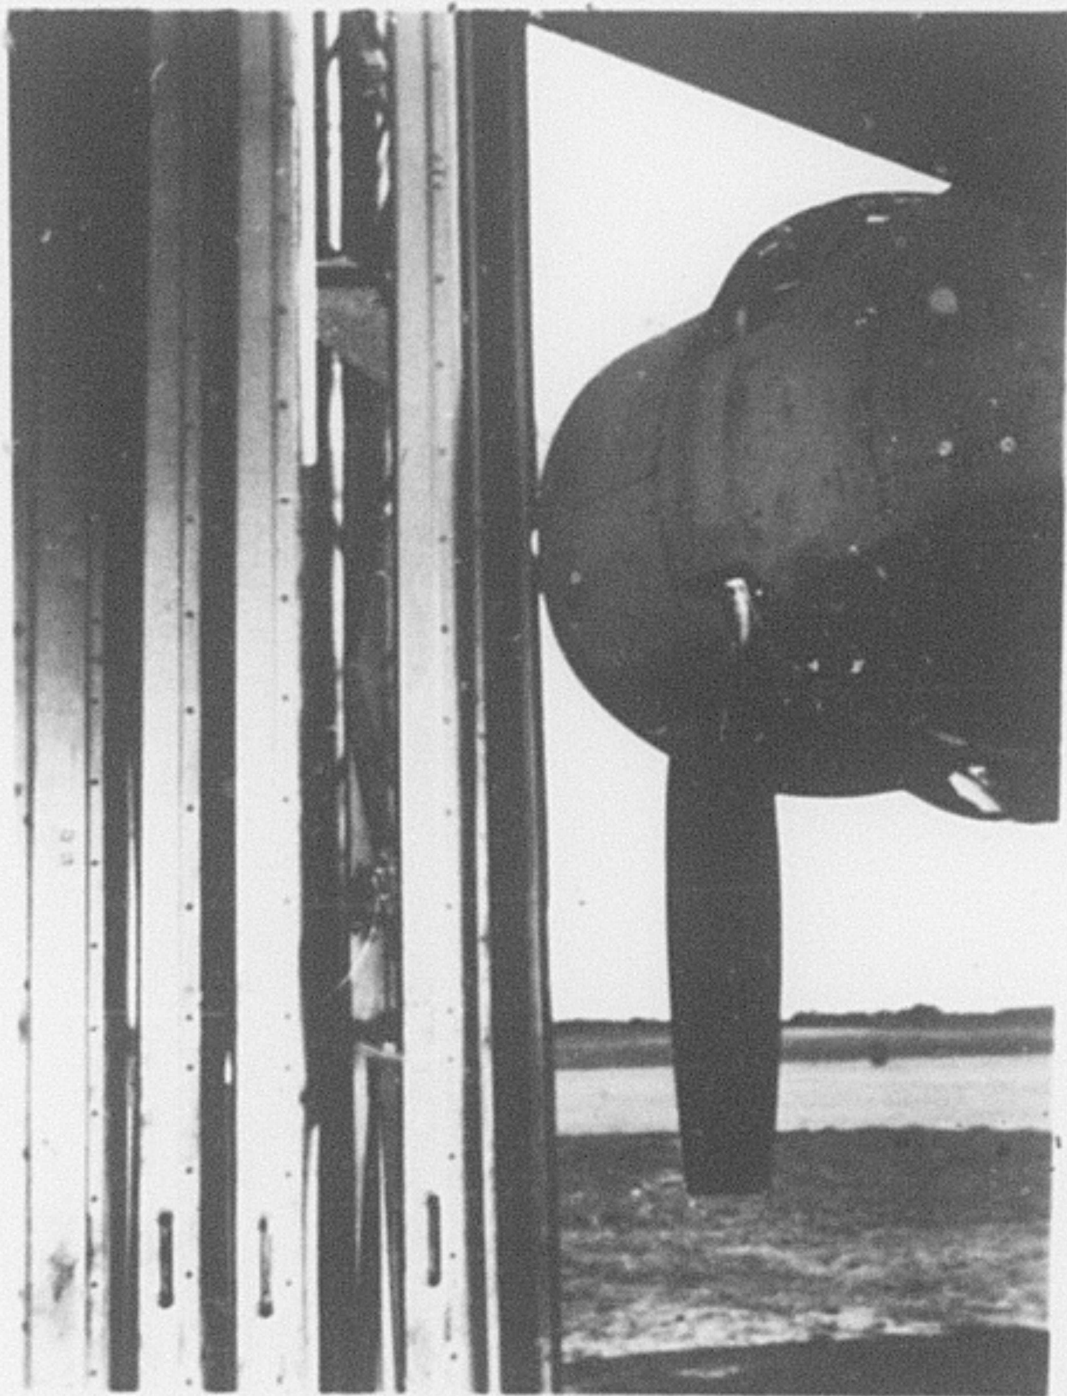
PROP & HANGAR DOOR DAMAGE 9-8-43
