REPORT OF MAJOR ACCIDENT

No. - Bollinger - Zalma - 2 miles Northeast Walden A.A. Fld - 38 Mi. NNW

4. AF Nos. of Aircraft Involved (File separate Form 14 for each aircraft) _____ DATE 13 Dec 44 HOUR AND TIME ZONE 0215 CWT DAY NIGHT

1. AIRCRAFT NO. 43-16047 2. TYPE MODEL SERIES C 47 F A 3. HOME STATION Malden Army Air Field, Malden, Mo.

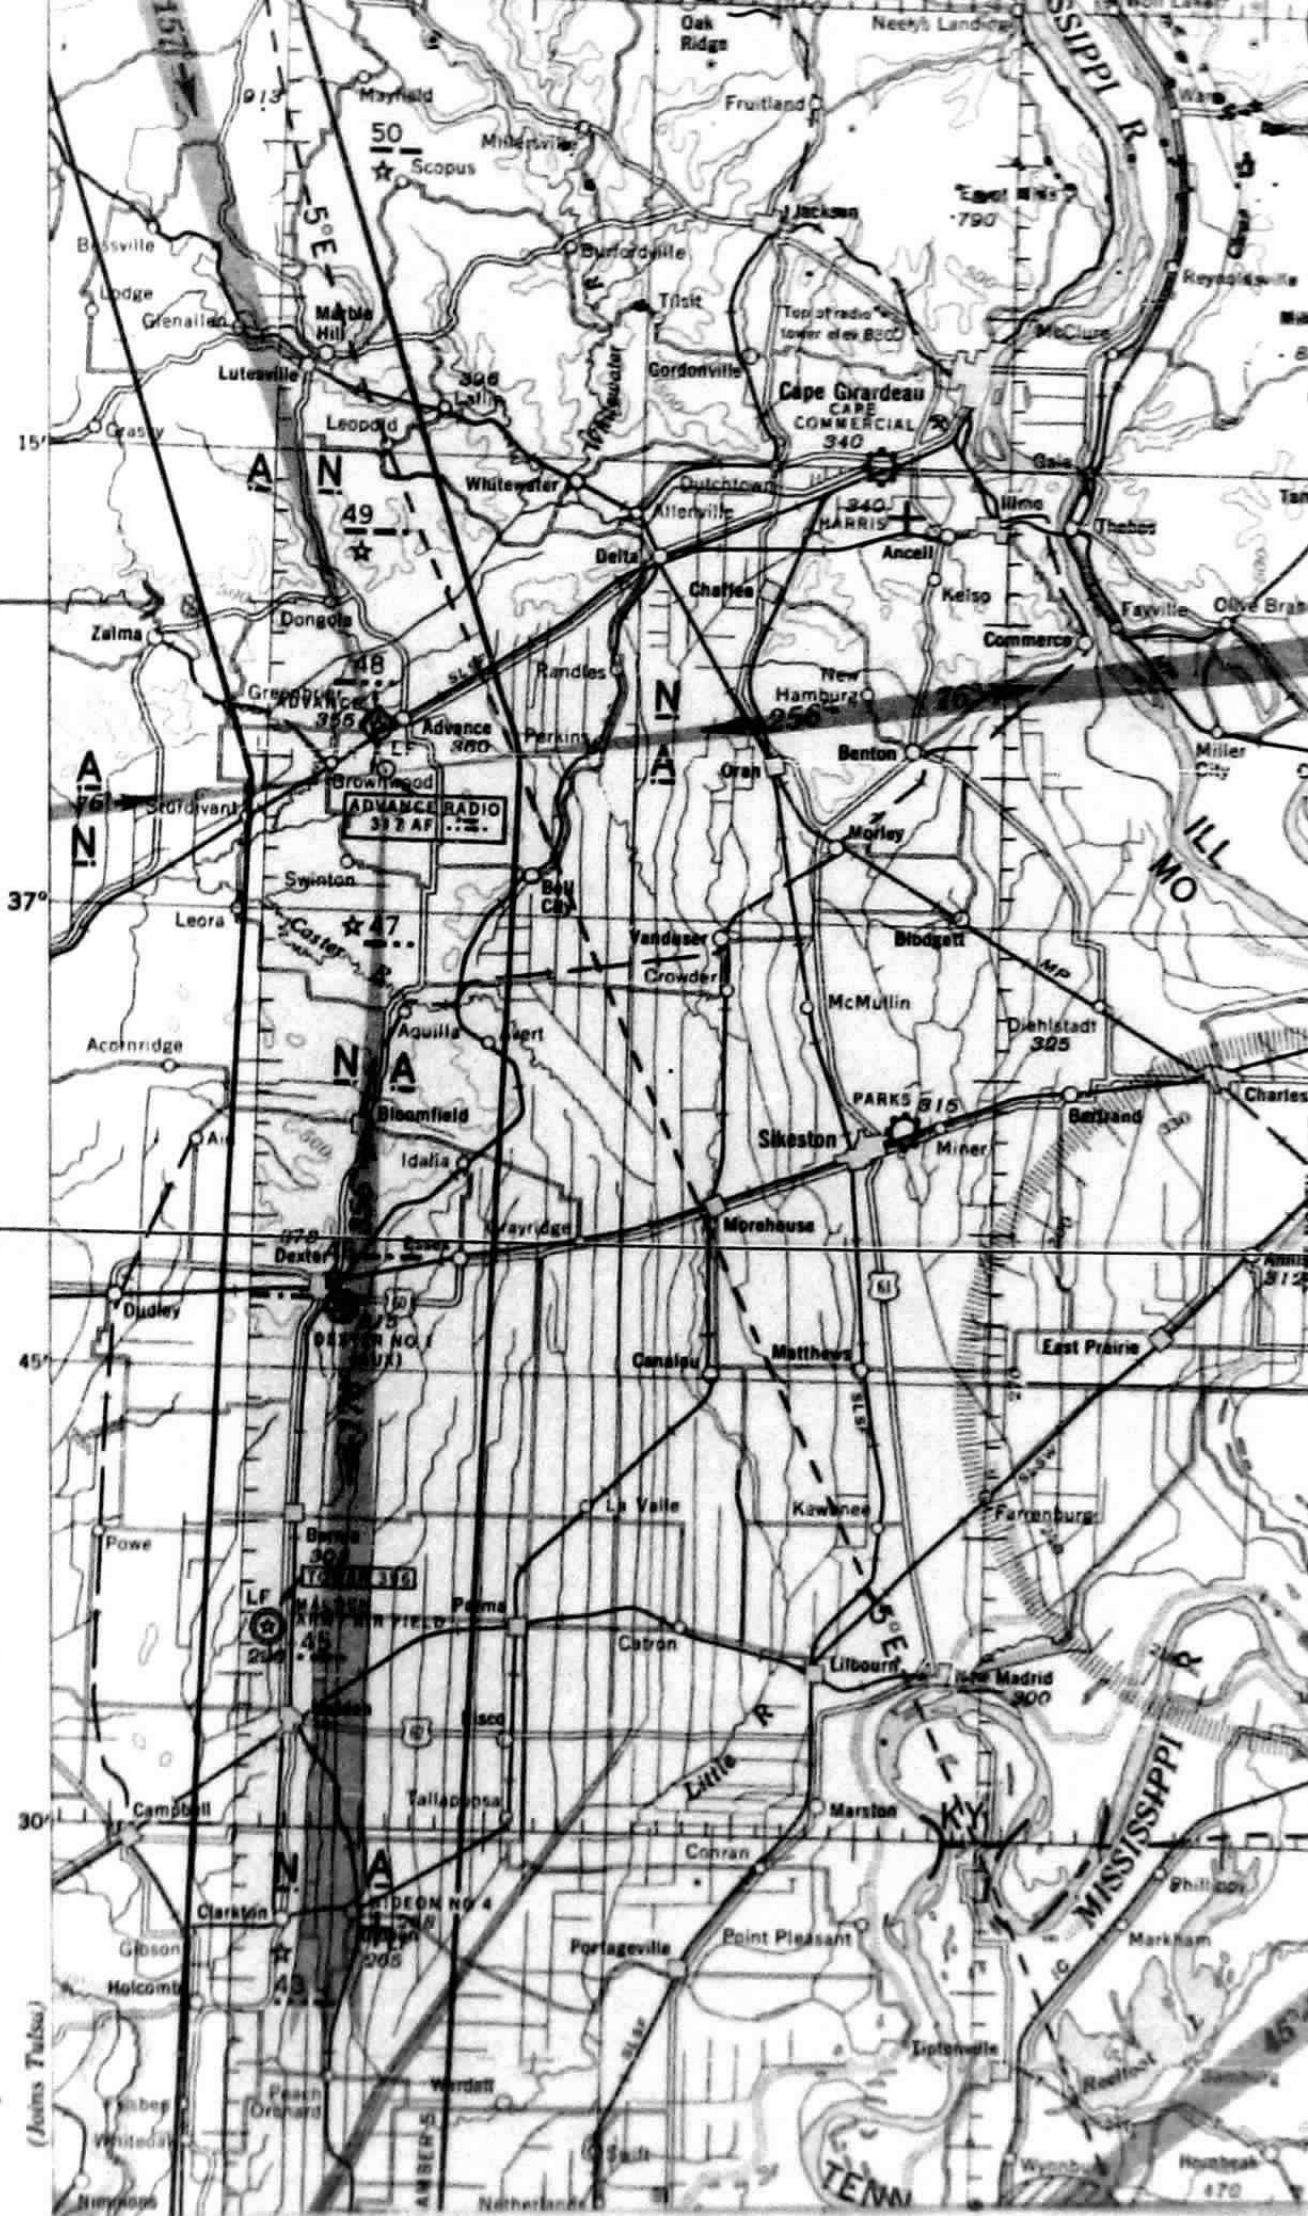
Scene of Accident C-47A, 43-16047
PILOT: ROBERT M. MOSER, 2nd Lt.
DATE: 13 December 1944
Elevation .. 500 ft.

The scene of the accident gave very little evidence as to the possible cause or causes that resulted in the crash. The plane, flying from north to south at a speed estimated by the Accident Board to be between 180 and 200 MPH hit the tree tops in a left wing low attitude of 45 degrees or more, sliced through 36 yds. of trees, glanced from the top of the first ridge, shown in accompanying diagram, and exploded upon impact with the next ridge. While the apparent attitude of the airplane was left wing low, the direction of travel was straight forward, more or less eliminating the possibility of a spiral.

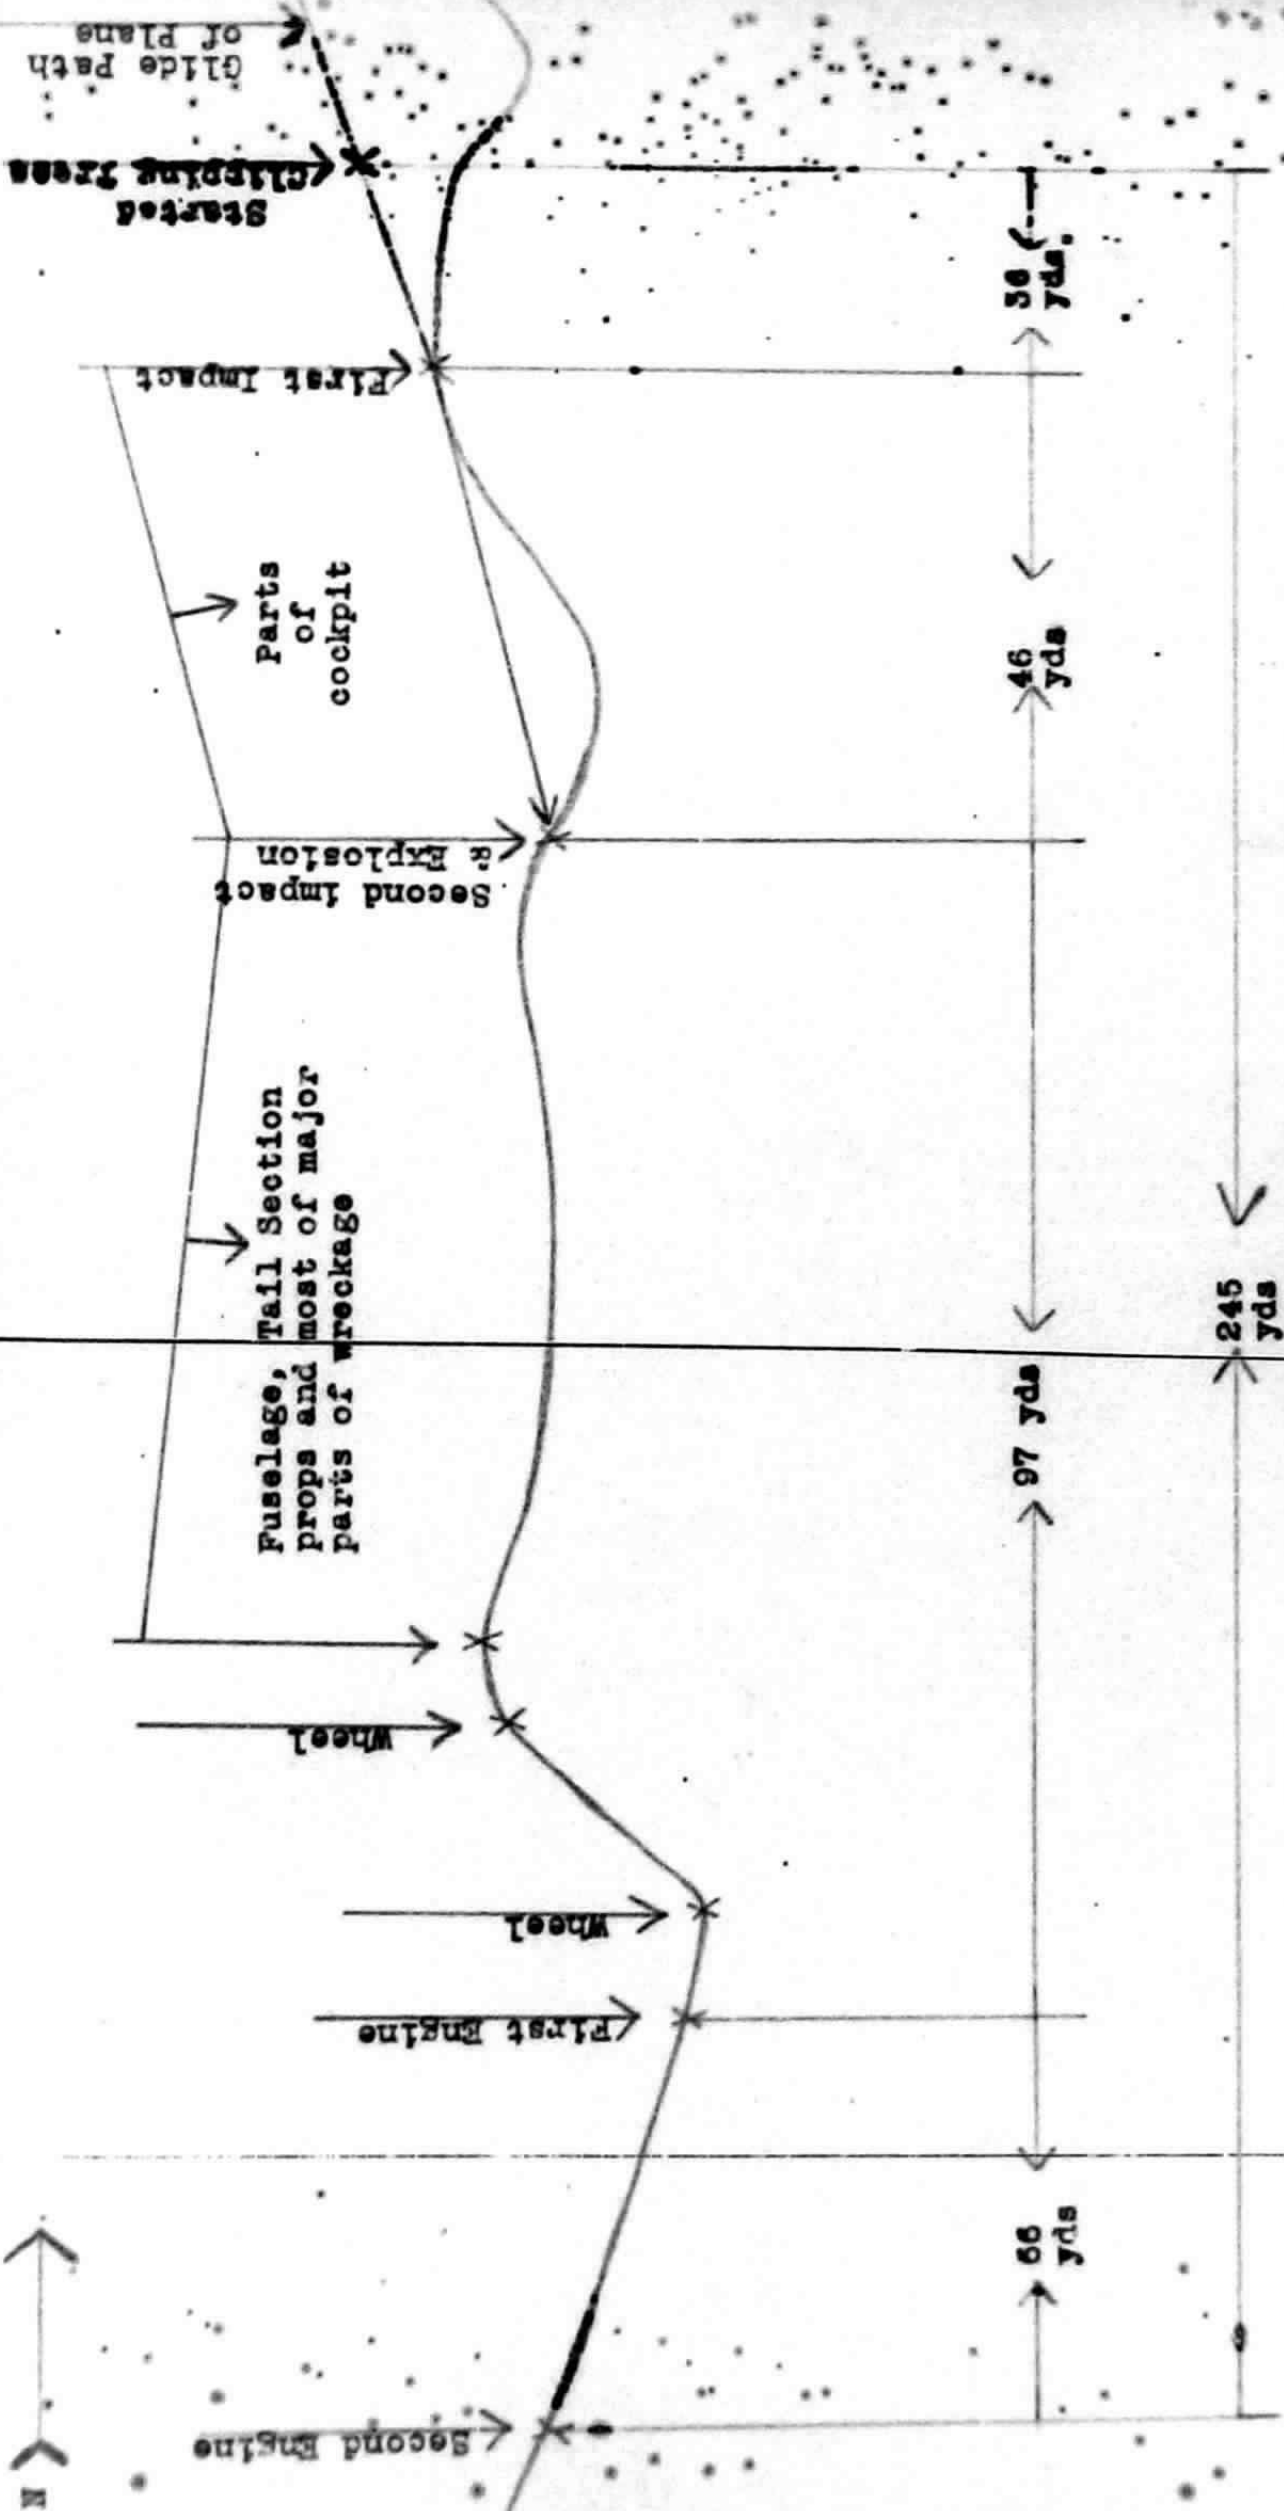
Cross Section of Terrain
 Scene of Accident C-47A, 43-16047
 PILOT: ROBERT M. MOSER, 2nd Lt.
 DATE: 13 December 1944

All rated personnel of this station are being directed to exercise more diligence in checking their altitude above the terrain. Emphasis is also being placed upon variations of the terrain elevations in the local flying area. While they are not great in this area, and the elevation at the scene of the accident was only 204 feet above the local field elevation, it may have had a bearing on this accident.

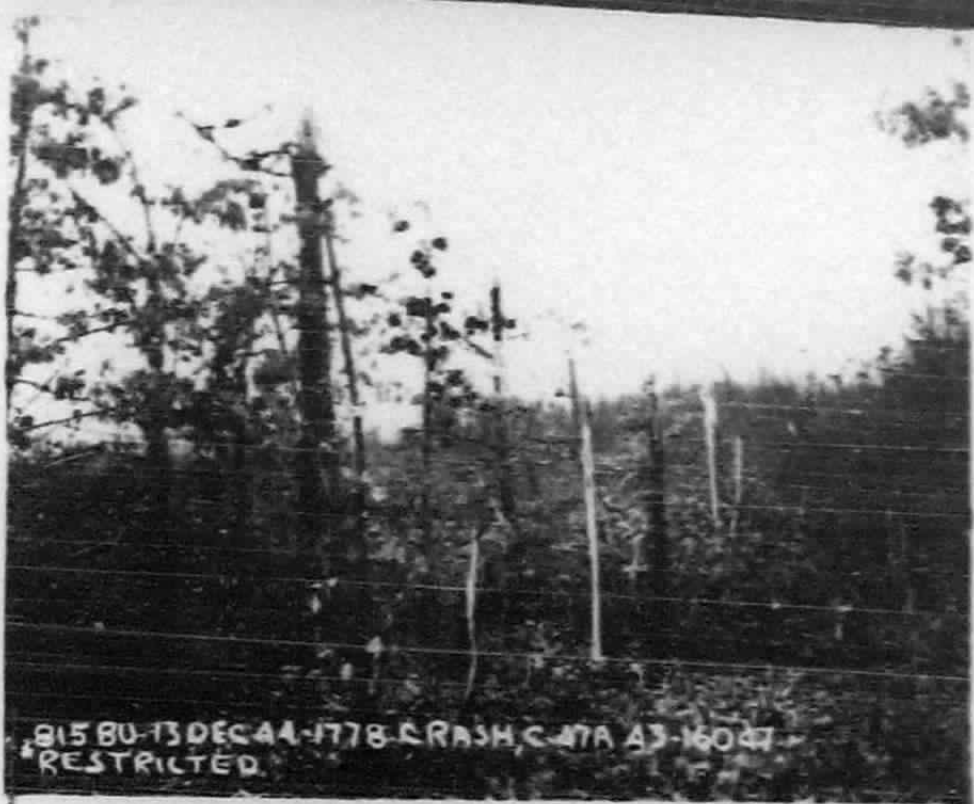
#1
Looking North:
Where plane first
started clipping
the trees

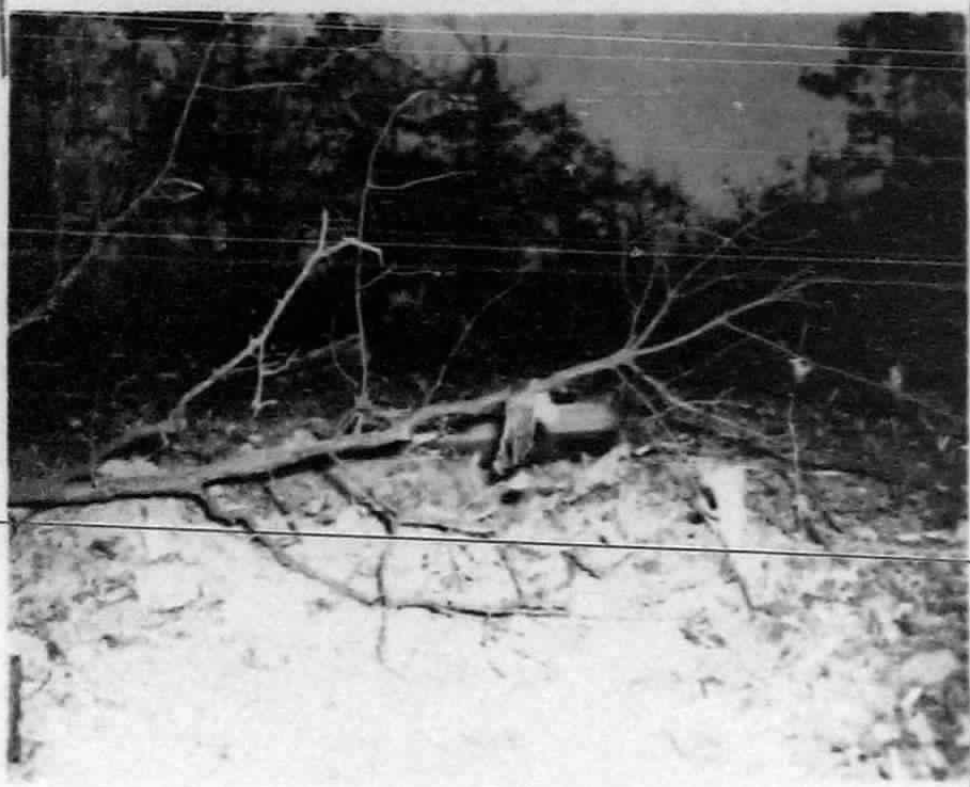
#2
Looking North:
From point of first
impact on top of
first ridge in
diagram

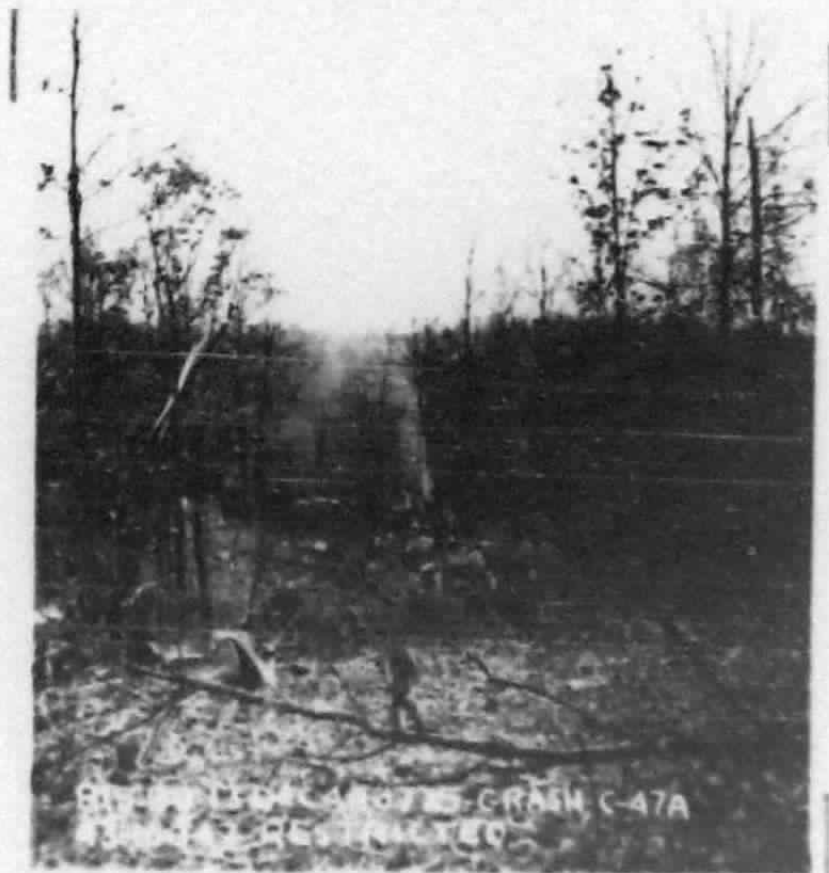
#3
Looking South:
From point of first
impact

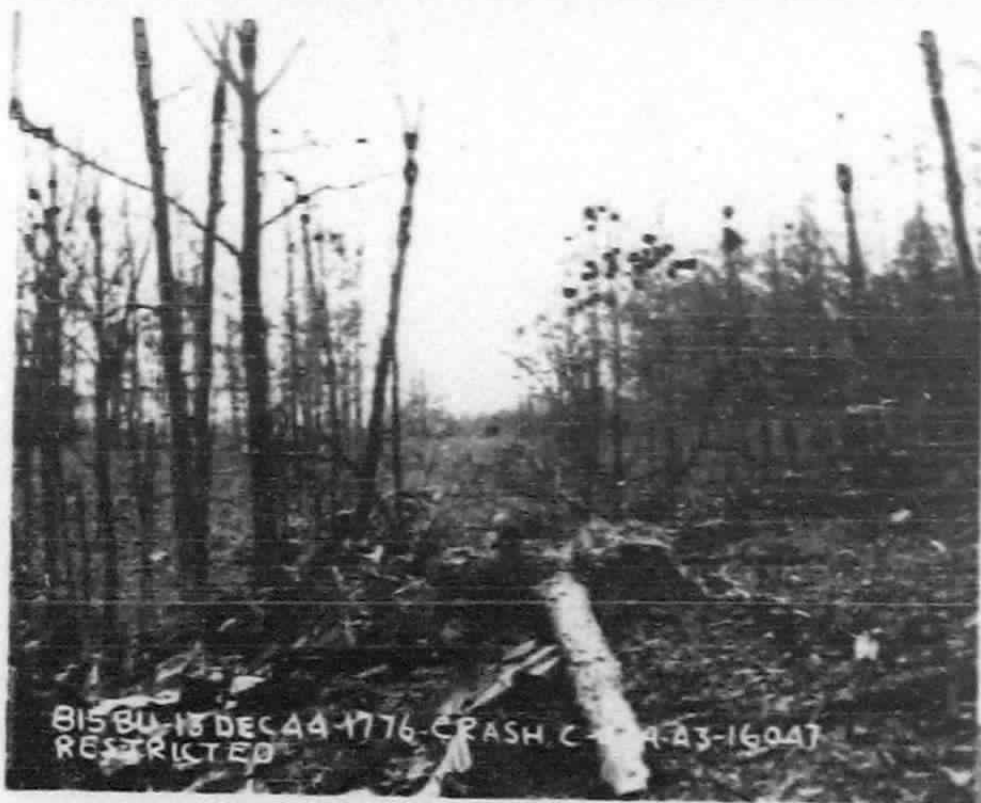
#4
Looking North:
From second ridge
where explosion
occurred.
